**INITIAL STUDY OF A
COAL GASIFICATION WASTE SITE
BROCKVILLE, ONTARIO**

Report prepared for:
Waste Management Branch
Ontario Ministry of the Environment

Report prepared by:
Trow, Dames & Moore

MARCH 1991

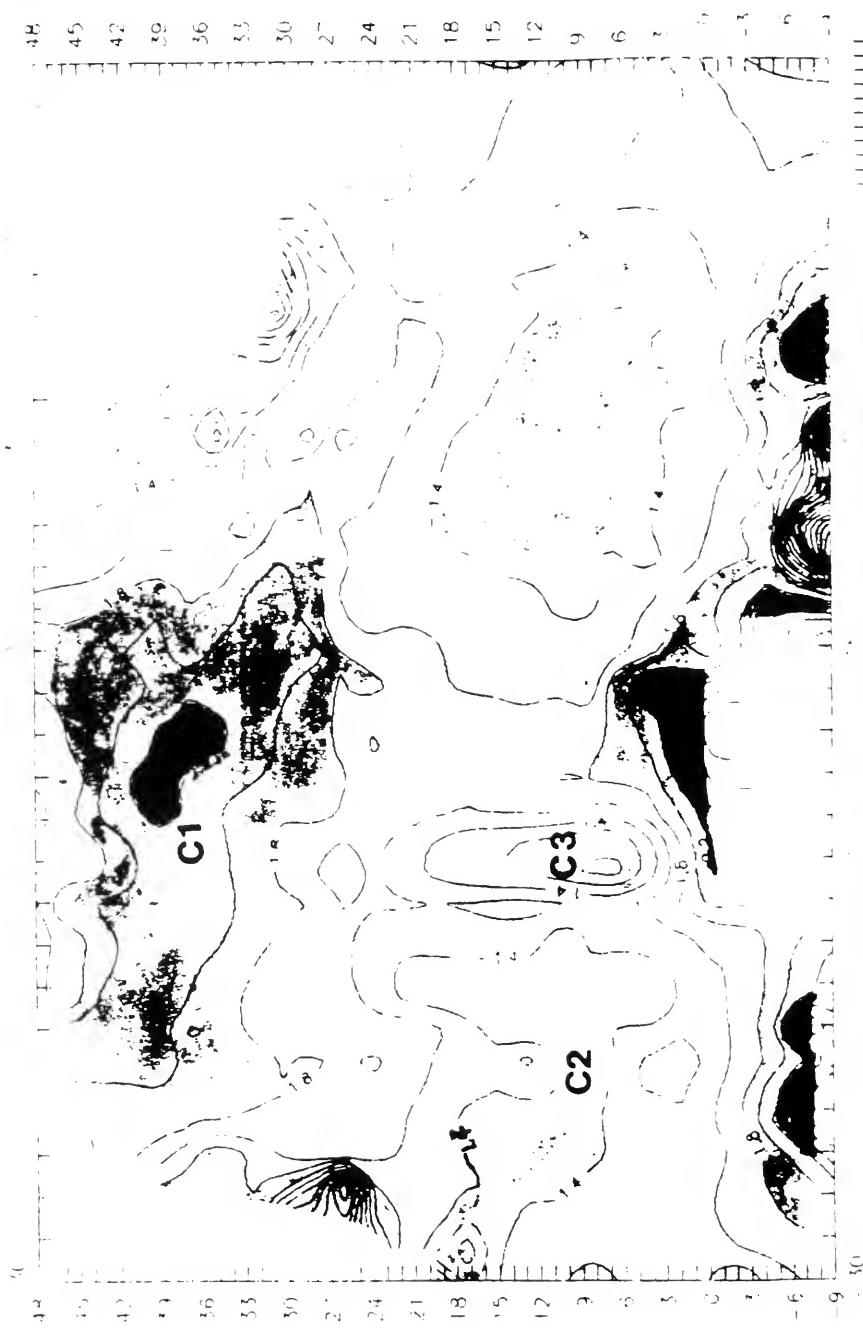
**Figure 2 BROCKVILLE COAL
GASIFICATION PLANT { Log Cond. }**

Figure 2 shows the log of the conductivity readings. The northern quarter of the plot is dominated by the influence of present buildings. The southern part of the grid has a large east-west trending high (C1) that is likely related to previous use of the land. The green low (C2) along the eastern part of the grid probably indicates the limits of former buildings. Another low (C3) is elongate and likely to be either a pipe, or utility.
